PM5355

S/UNI-622™ ATM Reference Design with Multimode Optics Errata

Issue 1: August 14, 1997

PMC-970820 ISSUE 1

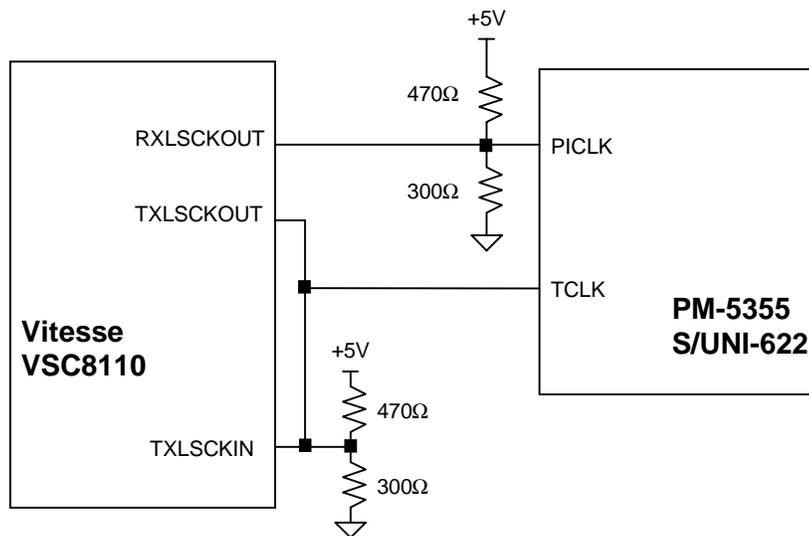
The Vitesse VSC8110 clock output loading presents a problem. The VSC8110 spec shows $V_{ol} = 0.5\text{ V}$ at 8 mA, and $V_{oh} = 2.4\text{V}$ at 2.4 mA. The original design has a 220Ω pullup resistor and a 330Ω pulldown resistor. V_{oh} does not present a problem, but V_{ol} would have to sink $(3\text{ V}-0.5\text{ V})/132\Omega = 18.9\text{ mA}$. This is 10.9 mA higher than what the VSC8110 can sink. To address the problem, the resistors should be changed to $470\ \Omega$ for the pullup one and $300\ \Omega$ for the pulldown one. Figure 1 shows the new pullup and pulldown resistors for both S/UNI-622's PICLK and VSC8110's TXLSCKIN terminations.

Figure 1. New values for the pullup and pulldown resistors

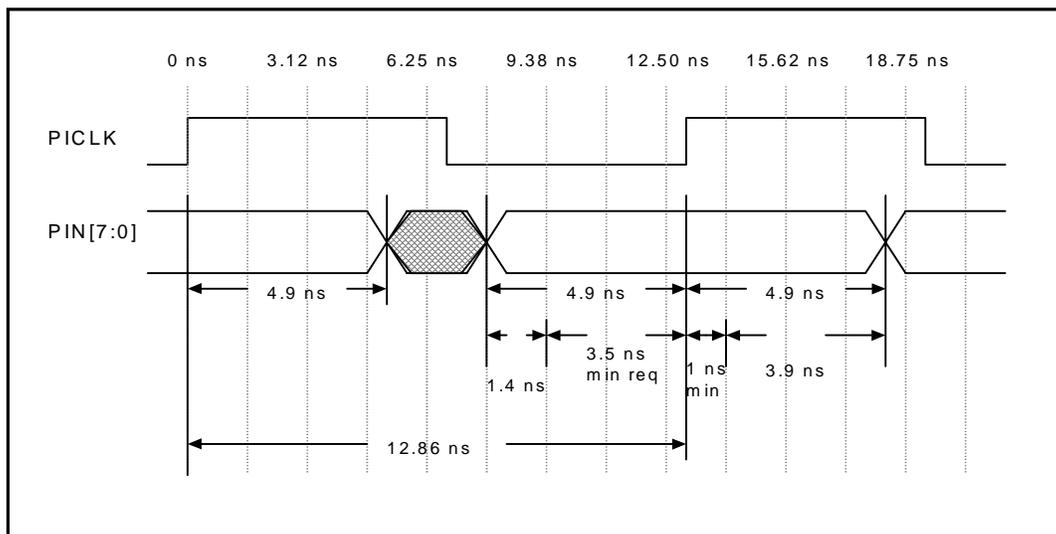
In the implementation section of sheet 2, S/UNI-622 Interconnect, on bottom of page 5, concerns were raised regarding to a 0.2 ns timing margin. This is shown as below. The entire section on the 0.2ns margin and the related timing diagram can be omitted since this timing requirement does not apply to the Vitesse VSC8110 and replaced with the following:

This identical timing exists with the FPIN input as well as the PIN[7:0]. Since there is only a 0.2ns timing margin on the setup time (data valid to the rising edge of clock) on the FPIN and PIN[7:0] inputs, precautions must be taken to avoid skew between these inputs. In fact, a slight delay (in the order of 1-5ns) in the data path would be advantageous and a slight delay (greater than 0.2ns) in the clock path would be intolerable. Hold time is not a concern on this interface since only 3ns are required and there are 11.9ns available. The Vitesse VSC8110 data sheet specifies that data is valid on RXOUT[7:0] at 4.9 ns before and after the rising edge of RXLSCKOUT. For the S/UNI-622, both the PIN[7:0] and FPIN has a setup time requirement of 3.5 ns and hold time of 1 ns. The Vitesse timing specification meets S/UNI-622's timing requirements with 1.4 ns margin for setup and 3.9 ns margin for hold time.

Figure 2 VSC8110 and S/UNI-622 Receive Interface Timing

Figure 2 shows the new timing between the VSC8110 and the S/UNI-622.
